# Prince Frederick's Battery

KOCSA Analysis, Existing Conditions, and Stabilization Report

Arcadia Preservation, LLC  
Gardiner Hallock  
12/9/2011

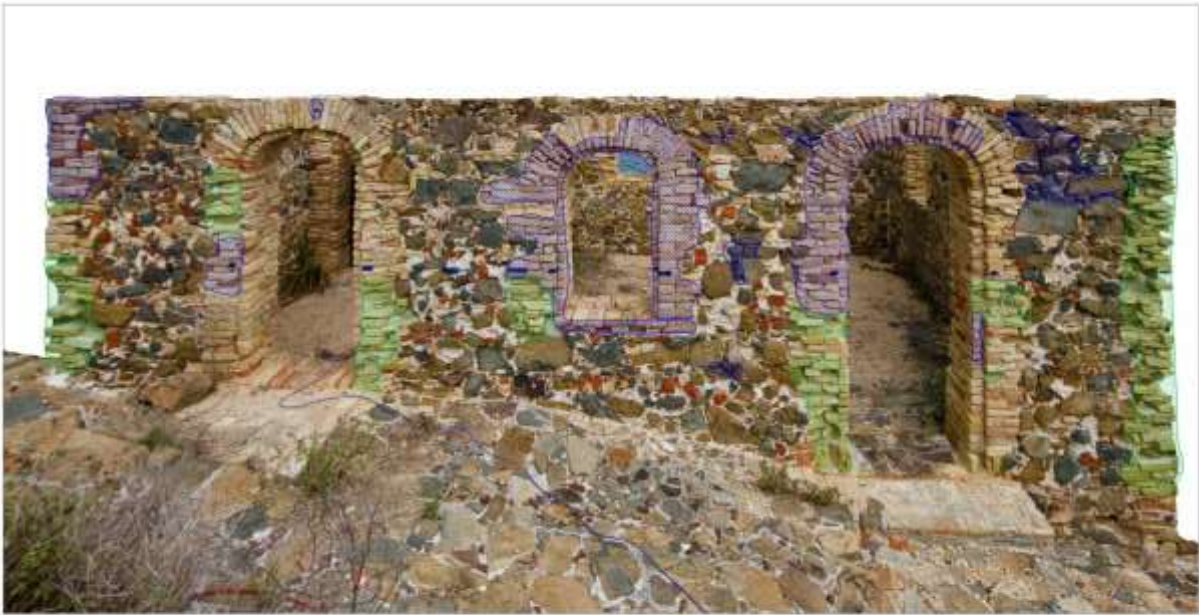
Quarters Building - West Elevation

The west elevation features a symmetrical design that includes a central window flanked by two doorways. The doorways access both the large and the small rooms while the window lights the large room. Of primary concern on this elevation is loss of bricks at both corners. While the loss of brick at the corners does not appear to be a structural issue at the moment, the continued failure of the brickwork will result in larger portions of the corners, and possible portions of the wall, failing. Loss of pointing mortar is also visible at scattered locations over the elevation, but the issue is primarily associated with the brickwork found at the corners and around the windows and doors. For both the windows and doors, the most significant issue is the loss of the mortar on the underside of the arches. Due to the way arches are constructed, the loss of even one or two bricks could result in total failure of the window or door head.

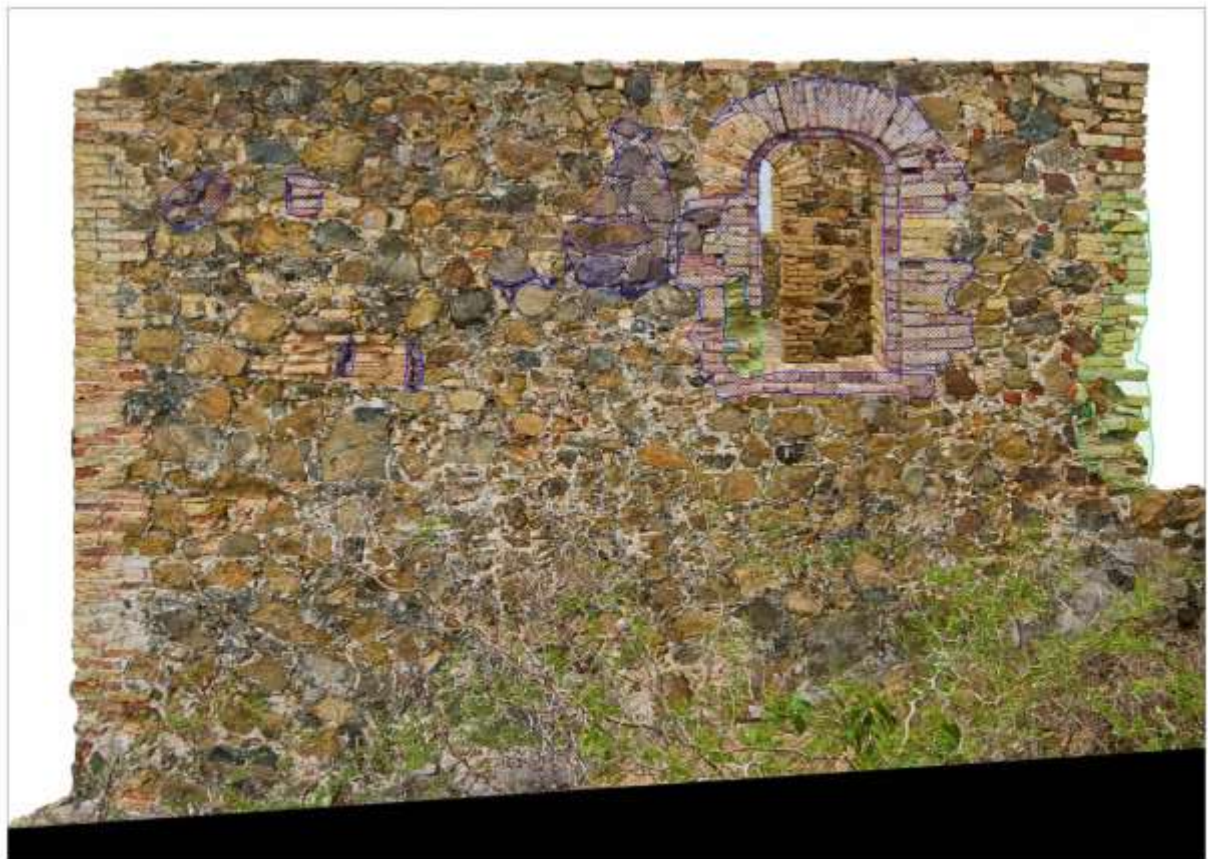
Quarters Building - North Elevation

The north elevation includes a single asymmetrically placed window similar to the windows found on the west elevation. Comparable to the west elevation, the principal condition issue is the deterioration of the bricks that form the structure's northwestern corner. Additionally, the bricks surrounding the window also show major signs of deterioration on the east side and have lost a large amount of the pointing mortar. Pointing mortar has also eroded away from the scattered sections of the stone work.

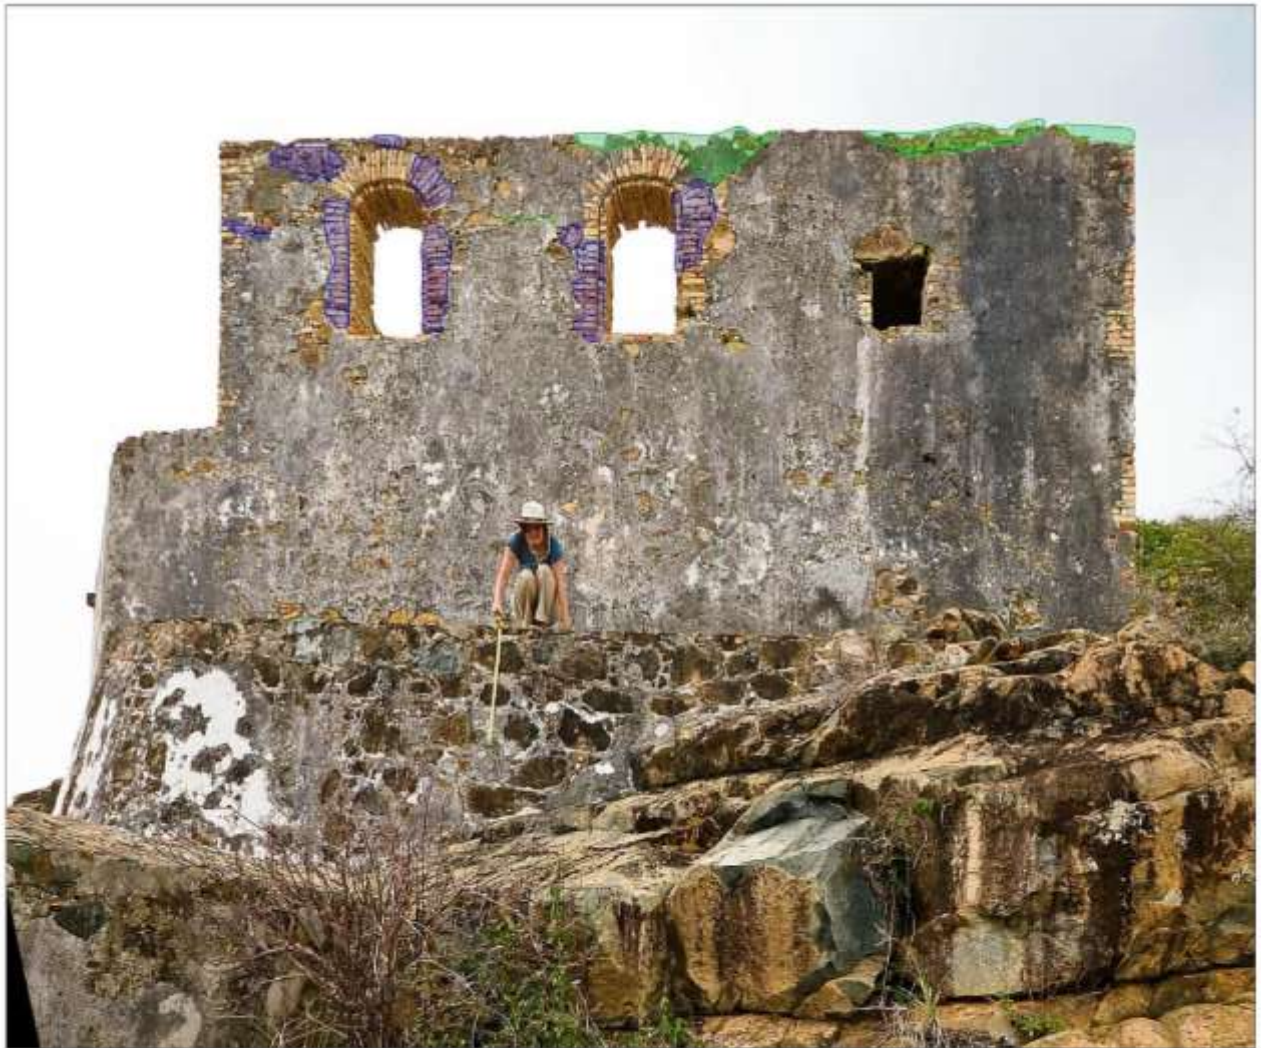
Quarters Building - East Elevation

The east elevation includes three windows, with the two southern most windows being typical arched-topped windows and the northern window holding a small, square-shaped, flat-headed aperture. Approximately 95% of the elevation is covered with Portland-cement stucco. Extensive cracking can be seen in the stucco from the level of the window sill up to the top of the elevation. Much of the missing stucco is also seen in this zone, suggesting that the two issues are connected. The principal condition issues are the large cracks seen associated with the top of the central window and the failure of the cement stucco (which traps water against the masonry). Finally, an iron pintle is found near the base of the northern window. The pintle is rusting and expanding, which is causing damage to the neighboring bricks.

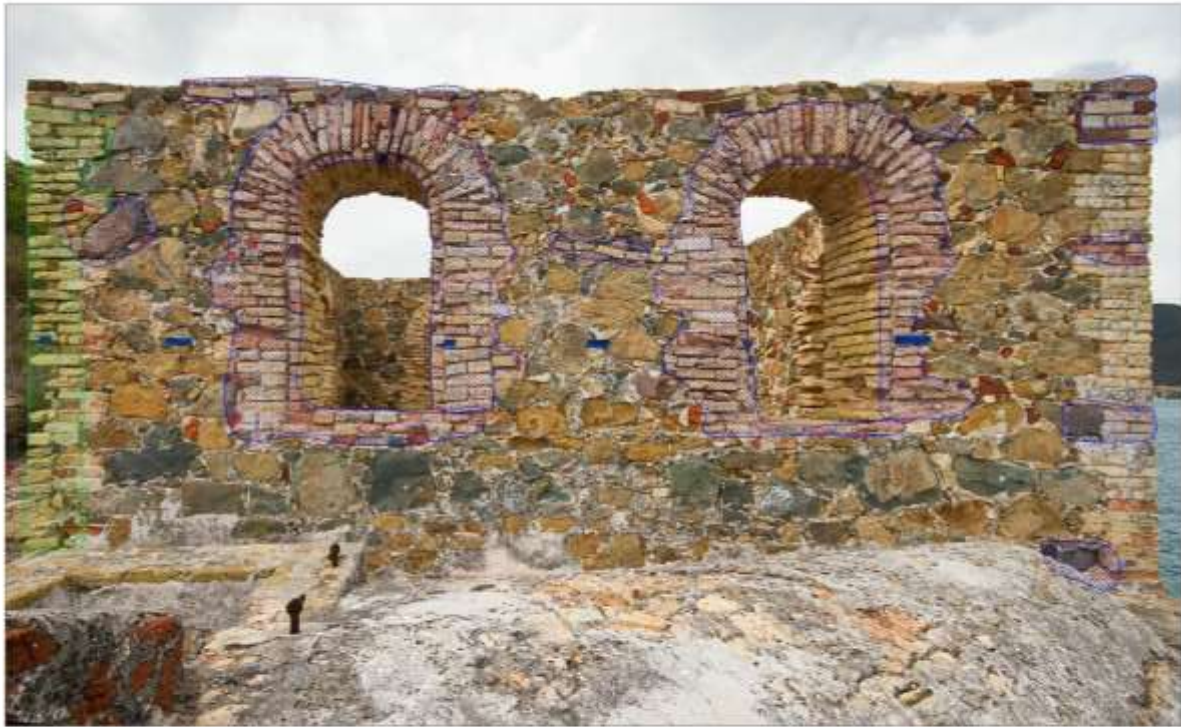
## Quarters Building - South Elevation

The south elevation features two symmetrically placed windows and only a small amount of cement stucco near the base of the wall. Similar to the north and west elevations, the principal conservation issues include the major loss/deterioration of the southwestern corner's brickwork and the major loss of pointing mortar around the windows. Additionally, the bricks that line the windows' interior have also lost a large amount of mortar and many show significant signs of deterioration.

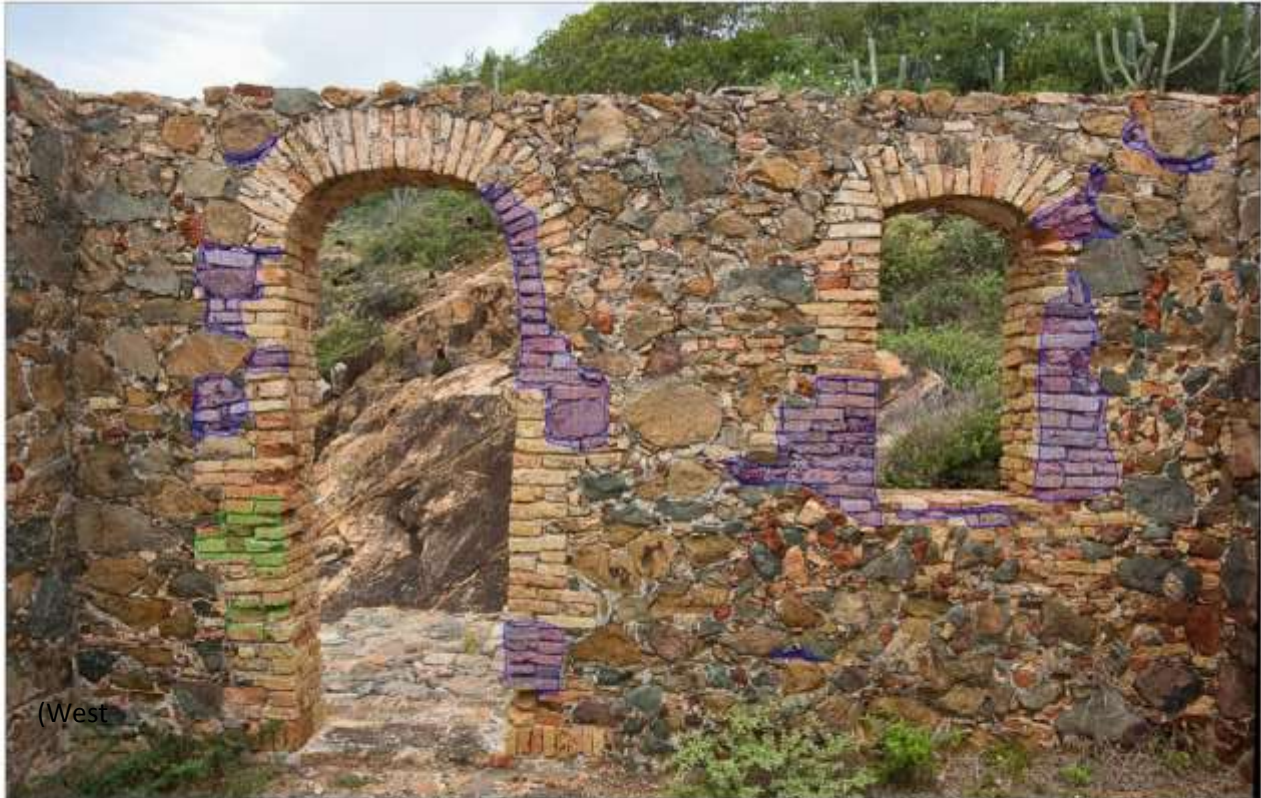
Quarters Building - Large Room (West Elevation)

The west elevation features an exterior doorway to the south and a window to the north. Other than a few deteriorated bricks found around the windows and doors the elevation appears to be in good shape. Some vegetation can also be seen at the base of the wall.

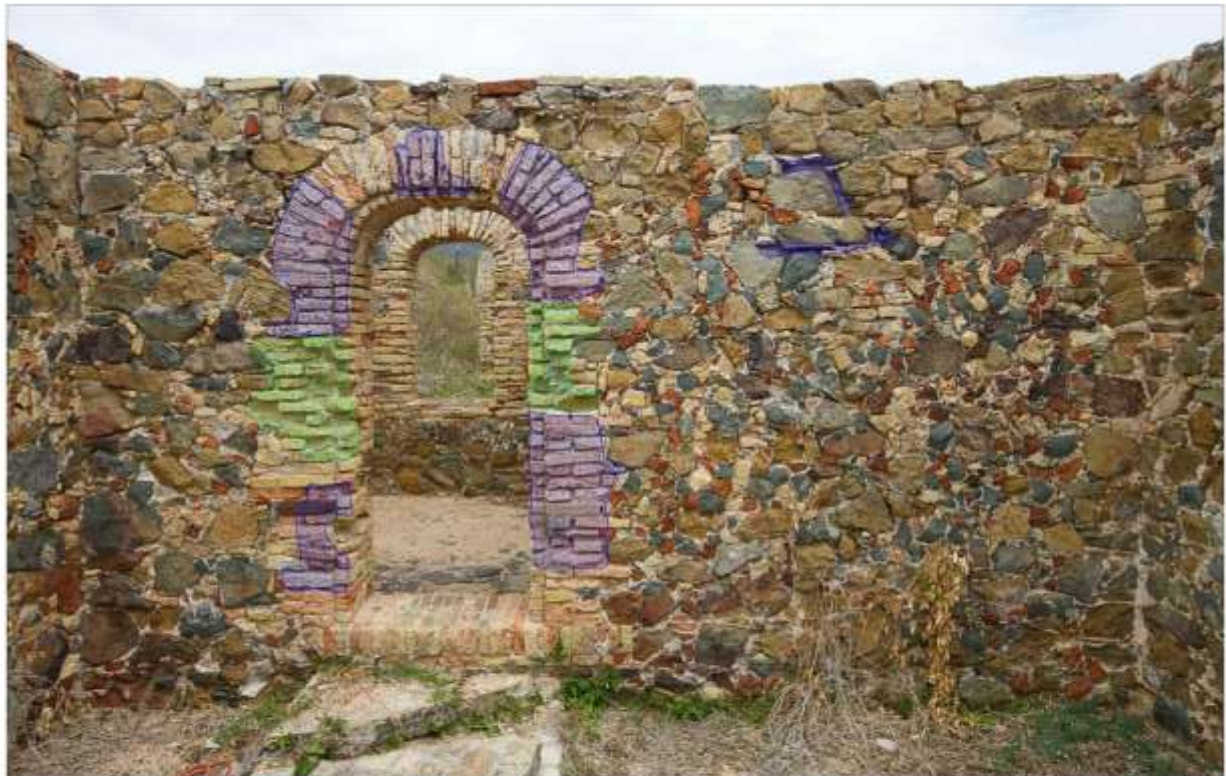
Quarters Building - Large Room (North Elevation)

The north elevation holds a single, arch-top door. While there are scattered areas of mortar loss across the elevation, the principal concern is the missing and deteriorated bricks on the doorway's jamb. A few stones are also missing from the top of the wall, although this is not a structural issue.

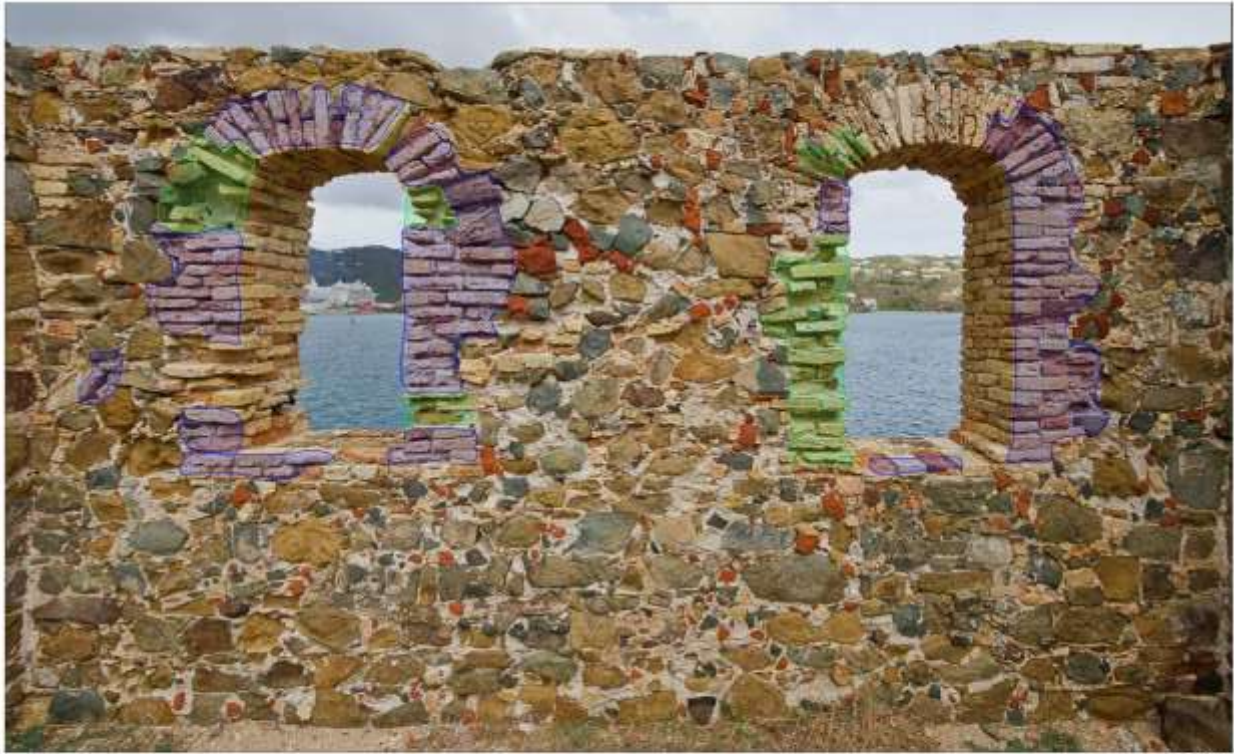
## Quarters Building - Large Room (East Elevation)

The east elevation is pierced by two arched-top windows. The jambs on both windows have areas of major brick loss/deterioration as well as major losses of pointing mortar. The interior jambs and soffits of the windows are also missing mortar and several stones are missing from the top of the wall. Additionally, small areas of mortar loss are seen across the elevation.

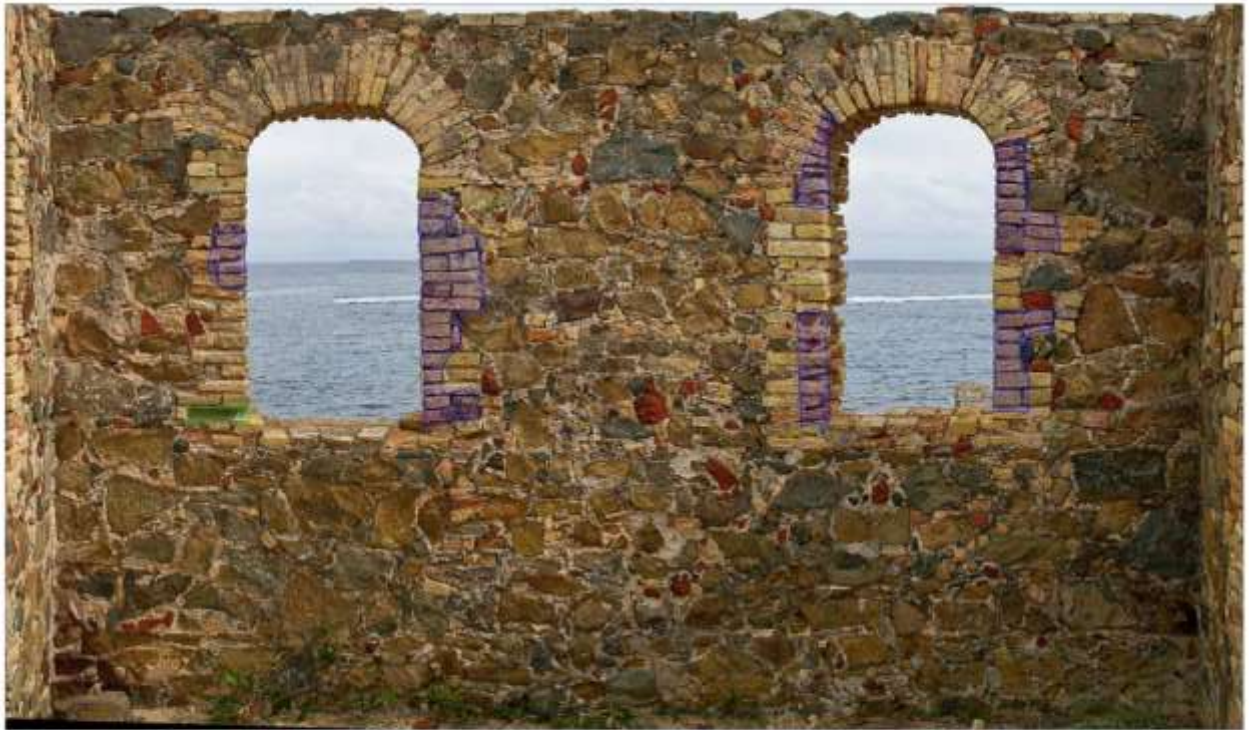
Quarters Building - Large Room (South Elevation)

The south elevation holds two arched-top windows. The elevation remains in fair to good condition and only several bricks are missing from around the windows. However, the brickwork around the windows shows significant mortar loss and there are scattered areas of mortar loss over the entire elevation.

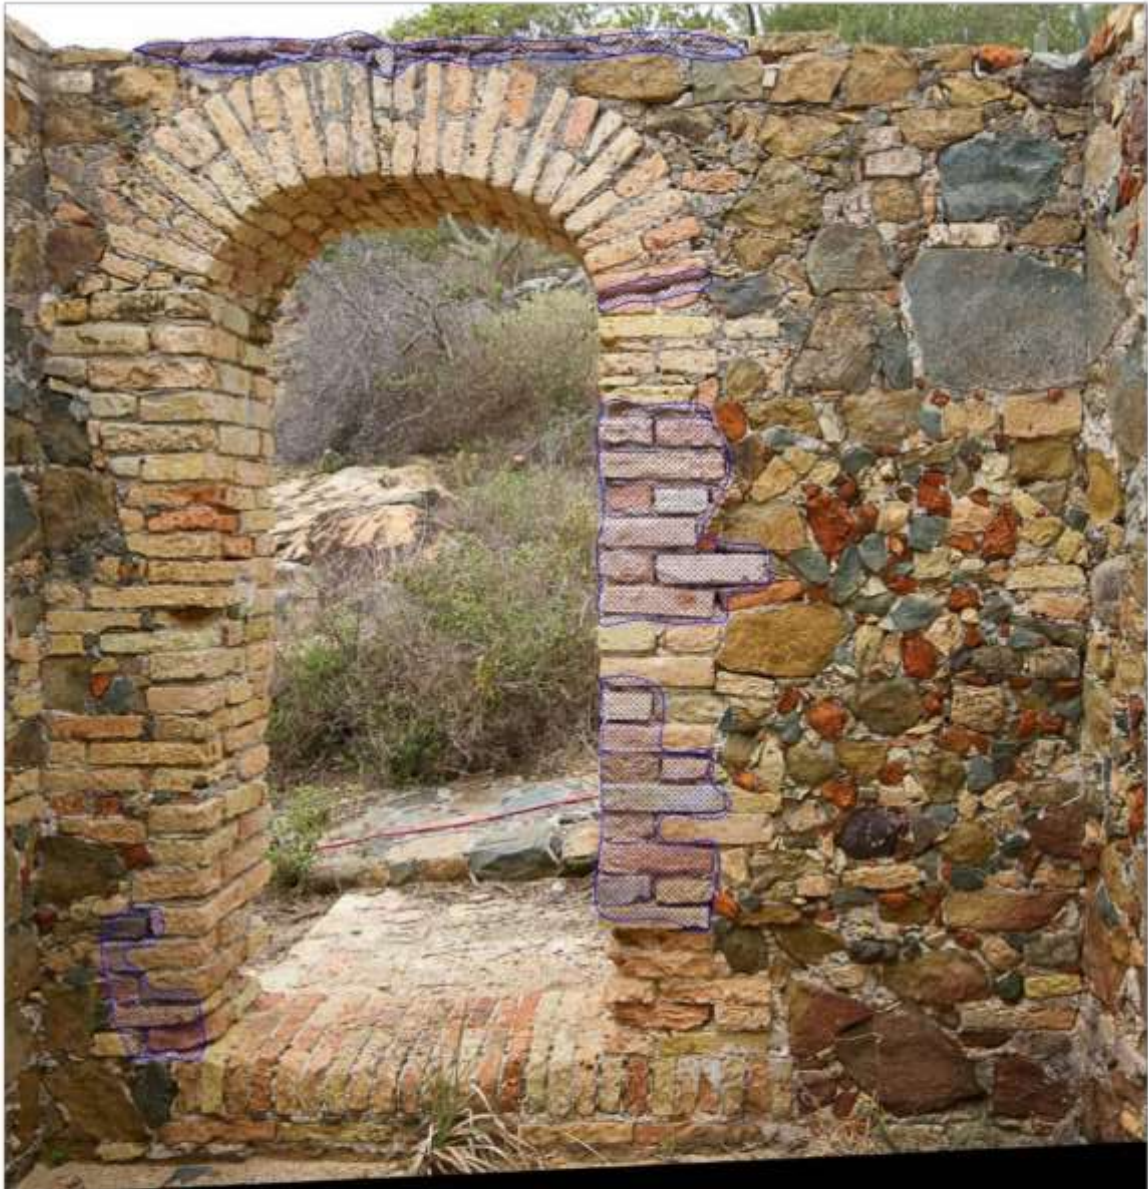
Quarters Building - Small Room (West Elevation)

A single, asymmetrical arch-top door is found on the southern elevation. The brickwork found around the door is missing several bricks and has large areas of mortar loss. Minor areas of mortar loss are also seen across the elevation as a whole.

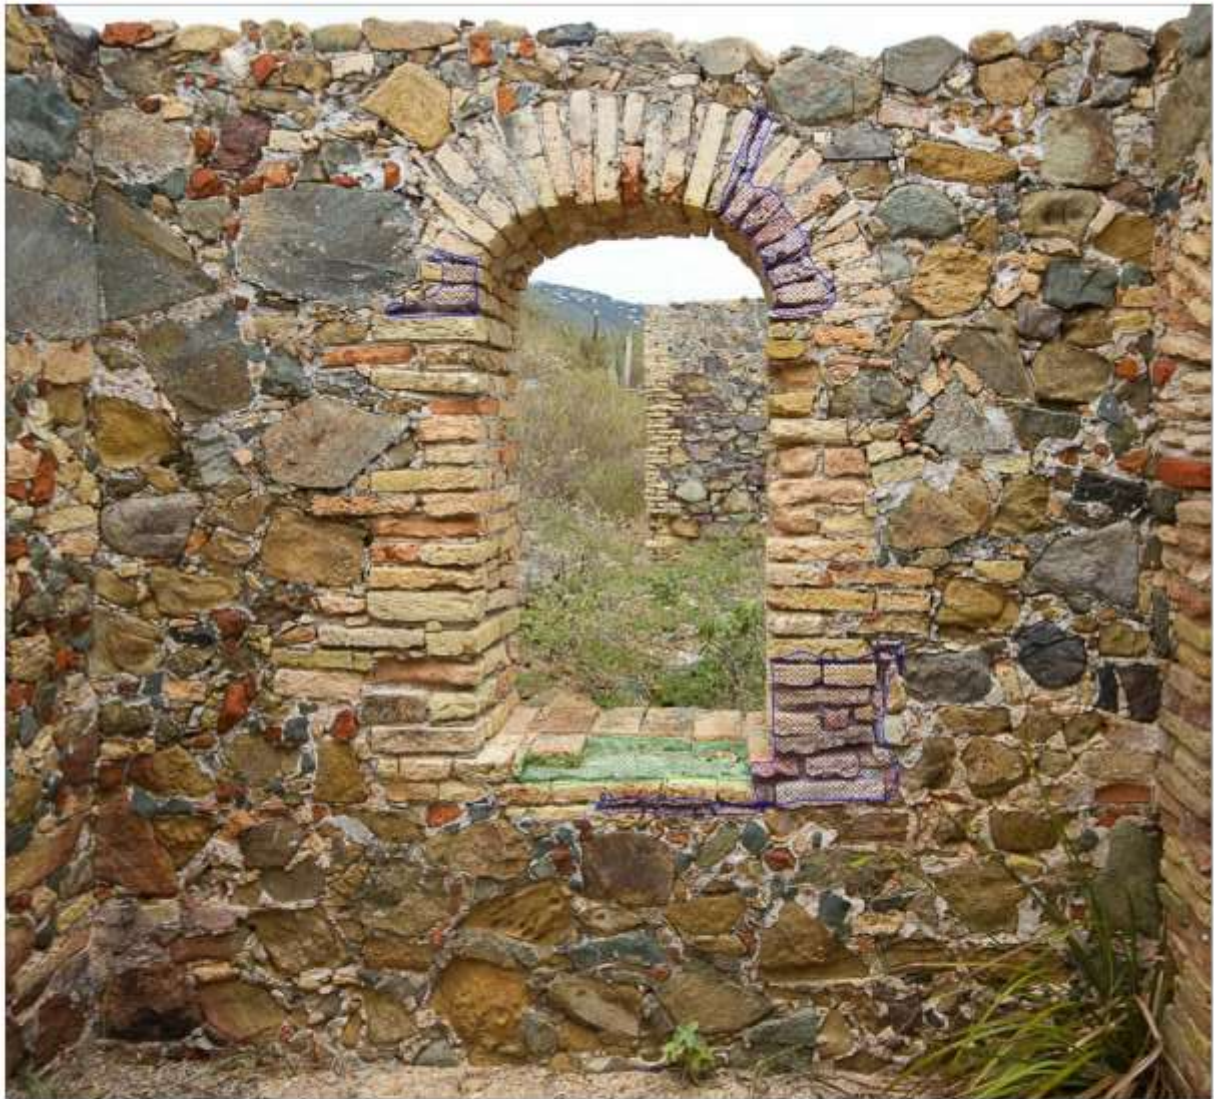
Quarters Building - Small Room (North Elevation)

A single, symmetrical arch-top window is seen on the north elevation. Similar to the west elevation, several bricks are missing from the brickwork that surrounds the window (including approximately 6 bricks from the sill) and there are minor areas of mortar loss across the elevation as a whole.

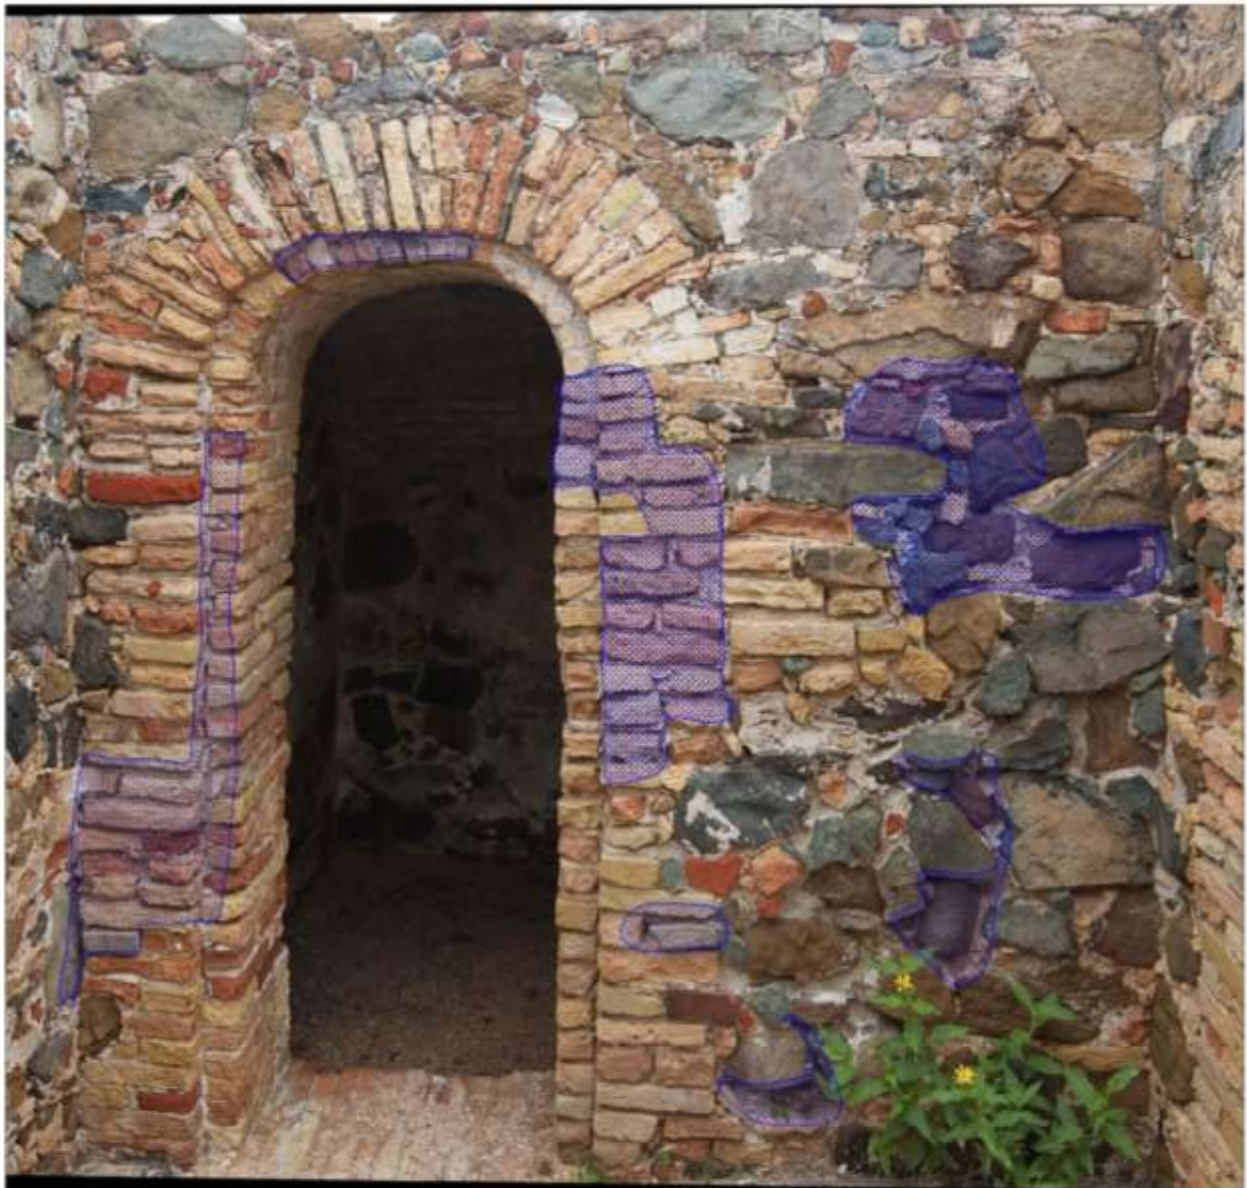
Quarters Building - Small Room (East Elevation)

A single, asymmetrical arch-top door is found on the east elevation. The brickwork found around the door shows signs of major deterioration and has large areas of mortar loss. Minor areas of mortar loss are also seen across the elevation as a whole.

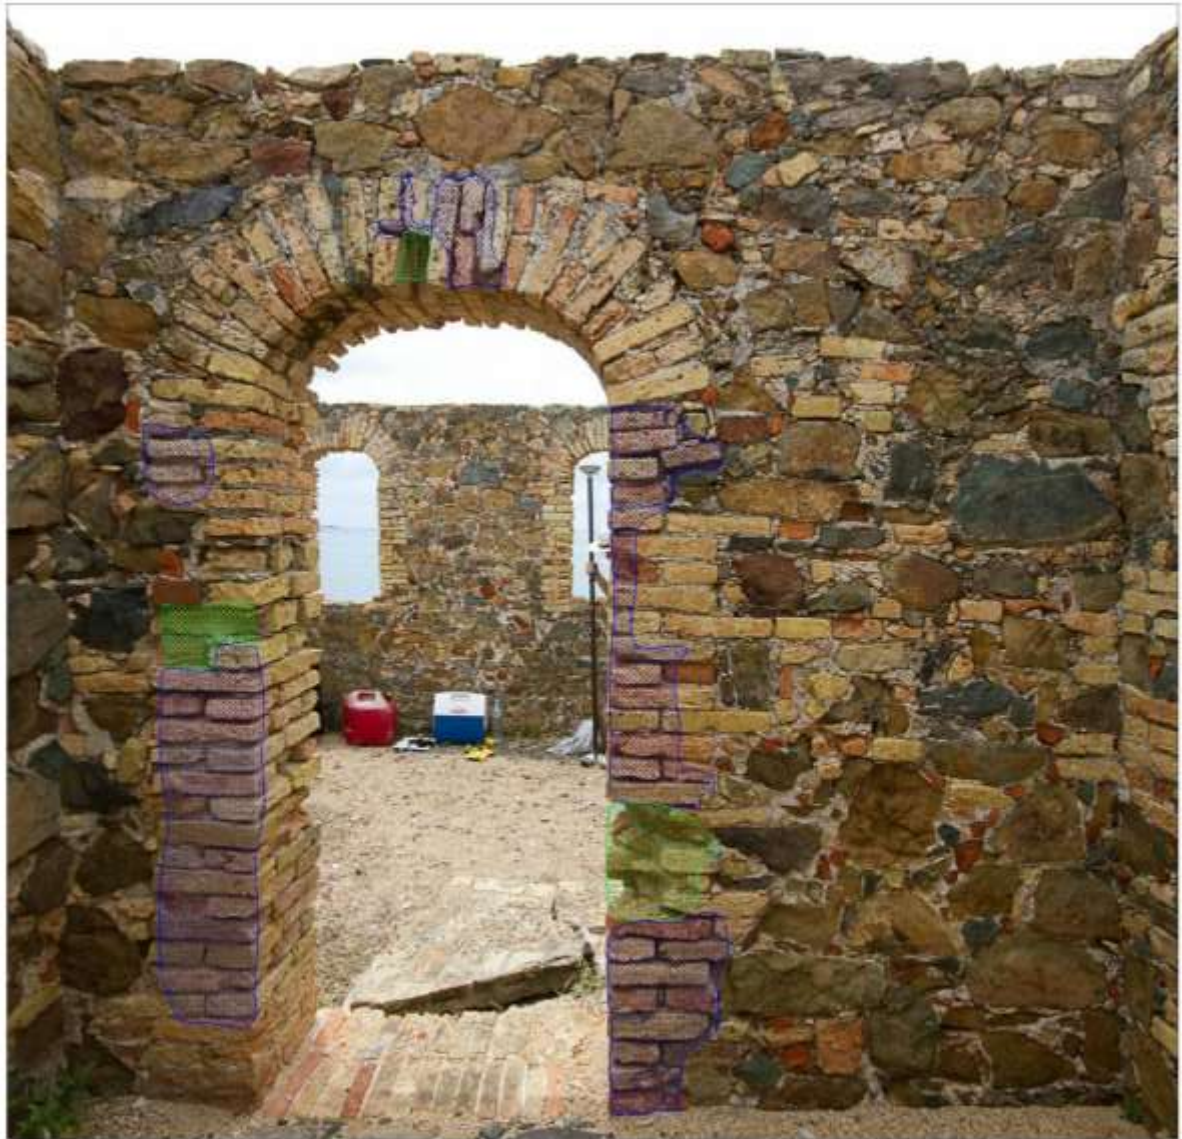
Quarters Building - Small Room (South Elevation)

A single, asymmetrical arch-top door is found on the South elevation. The brickwork found around the door shows signs of major deterioration and is missing several bricks from the arch and jambs. Additionally, large areas of major mortar loss are seen around the doorway and minor areas of mortar loss are found across the elevation as a whole.

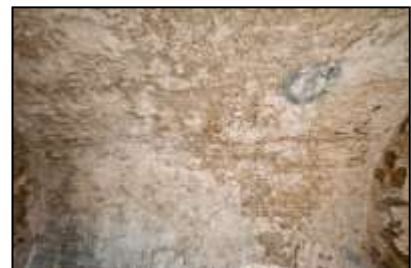
Figure 2 - Powder Room Ceiling

The powder storage room is covered by a barrel vaulted roof and the interior remains in good condition. The ceiling and portions of the north and east elevations are covered with what could be an early layer of whitewashed lime plaster. The most significant issue is the moderately large cracks seen in center of the ceiling's plaster. While these cracks indicate that some movement in the vaulting has occurred, the cracks do not appear to be active and will only need to be monitored to make sure they are not expanding. Additionally, a very small amount of mortar loss is seen across the interior.

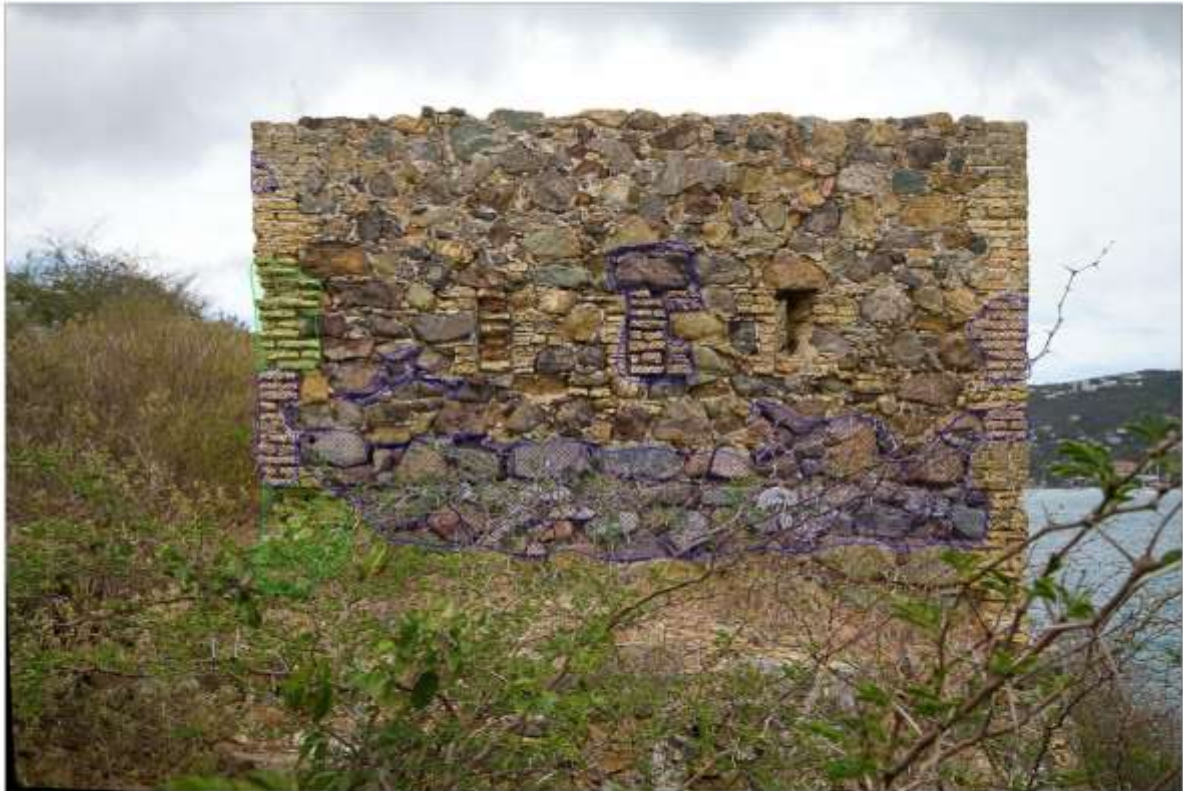
Kitchen/Latrine - South Elevation

The south elevation once had three small, narrow openings placed symmetrically across the elevation. At some point the two western openings were infilled with the same yellow bricks that are found around the windows and doors. The upper third of the building was also repointed or parged and scattered traces of a cement-stucco finish can be seen on the stones. The lower two-thirds of the elevation, however, was left un-repointed/parged and the un-repointed/unparged section shows major signs of mortar loss. The most serious condition issue is the loss of bricks and mortar on the southwestern corner.

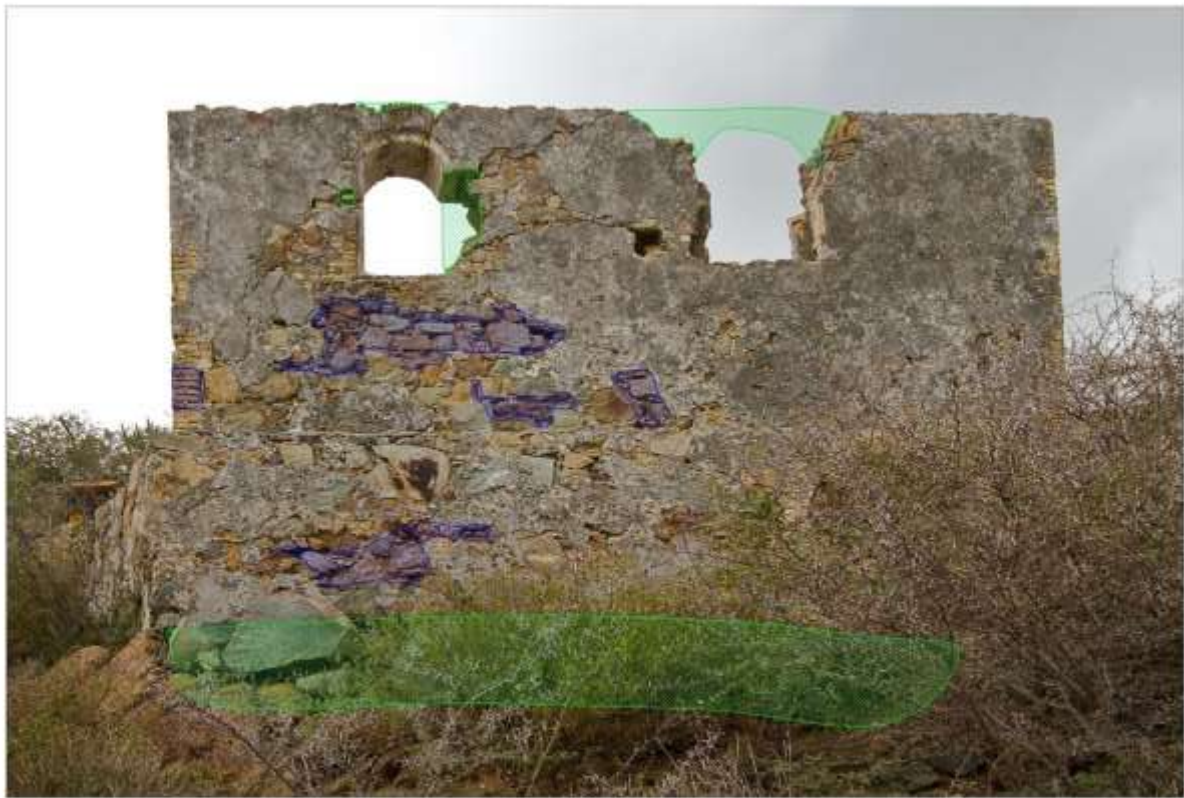
Kitchen/Latrine - East Elevation

The east elevation is fenestrated by two symmetrically placed window openings and one small, square opening found to the south of the northern opening. Approximately 60% of the elevation is covered with cement stucco and the arched head of the northern window has fallen in. The elevation's most pressing concern is the large amount of stonework that is missing from the foundation.

The cause of the missing stonework appears to be the result of water flowing down the hillside above the battery and into the small building. Once in the building the water is seeping through the floor of the structure and percolating through the stonework. As it flows through the masonry, it dissolves the lime in the mortar that binds the foundation's stonework, weakening the mortar and causing the stones to fall away. Other issues include missing bricks on the northern side of the southern window's jamb, large amounts of mortar loss where the stone and brickwork is exposed and large cracks found between the two windows that reveal serious structural stresses.

1. Rebuild the eastern foundation of the kitchen/latrine using matching stones laid in a naturally hydraulic lime mortar (naturally hydraulic lime (NHL 5) mixed with sharp sand at a 3 (sand) to 1 (lime) ratio).

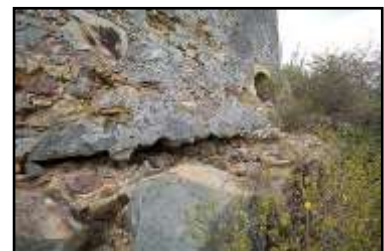
**Figure 3 - Degraded/Missing Foundation Detail**

Any missing stones, including the missing section of foundation under the Kitchen/latrine, should be replaced in kind with stone quarried (or just collected) from Hassel Island or St. Thomas. The stones should be set in a mortar made from naturally hydraulic lime. The fact that these new stones are set in hydraulic lime instead of normal lime putty will mark them as modern replacements to future conservators and craftsmen.

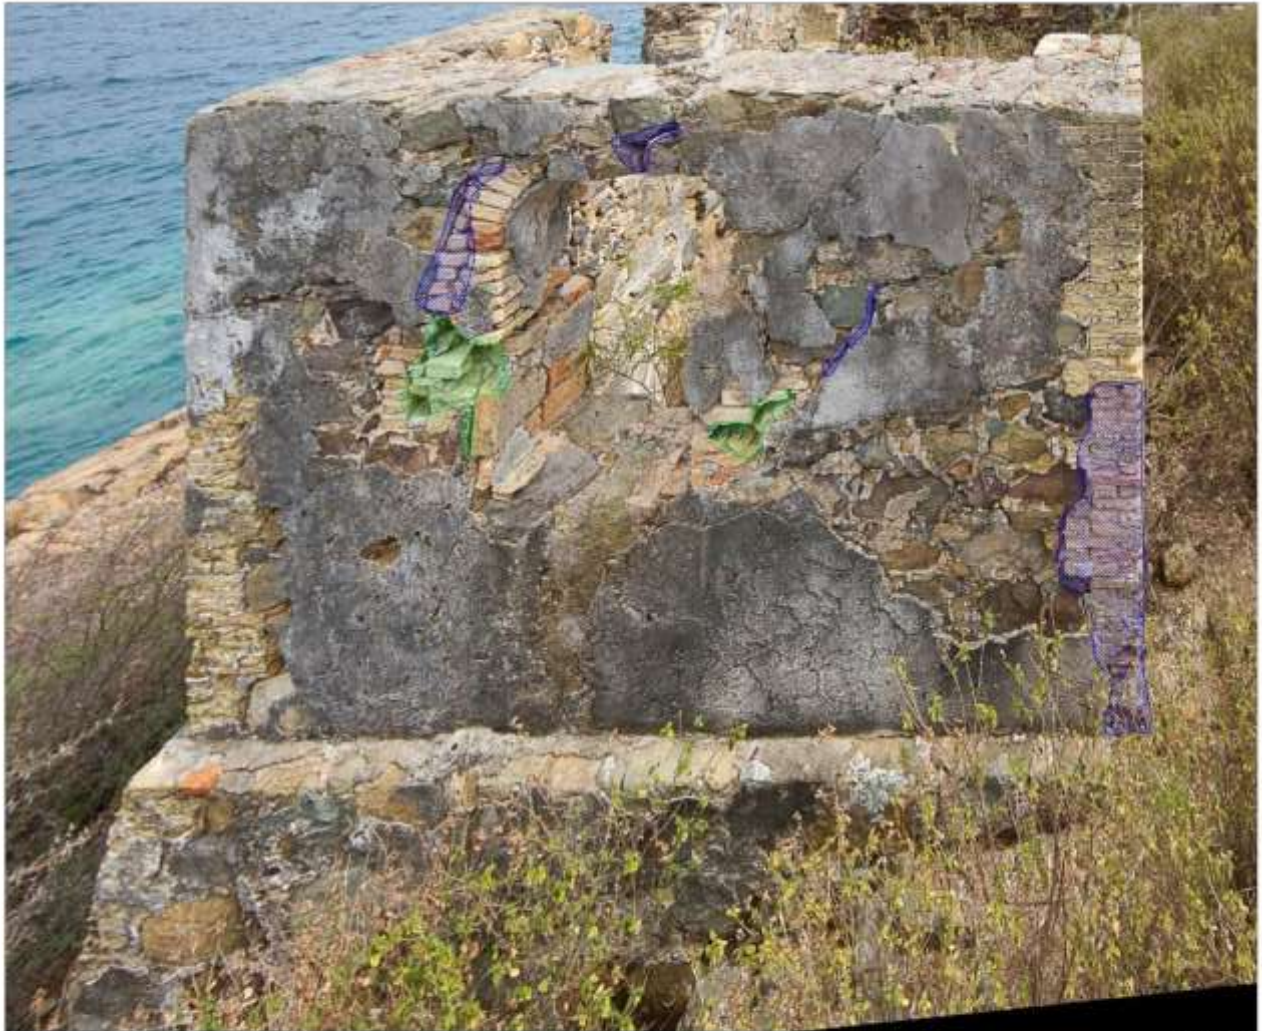
Kitchen/Latrine - North Elevation

The north elevation features a single, symmetrically placed window and approximately 90 percent of the elevation is covered with cement stucco. The window appears to be a later addition, as it does not appear on the 1780 Oxholm drawing and is constructed slightly differently from the structure's other windows (it uses rougher laid brick work that does not completely surround the window). The principal conservation issue for the elevation is the loss of stone and mortar on the window's jambs. The loss of mortar also extends to portions of the stone and brickwork on either side of the window. Finally, a large crack is seen running upward from the lower corner of the window's western jamb towards the structure's northwestern corner. The crack appears to be structural and may relate to the window's failing masonry.

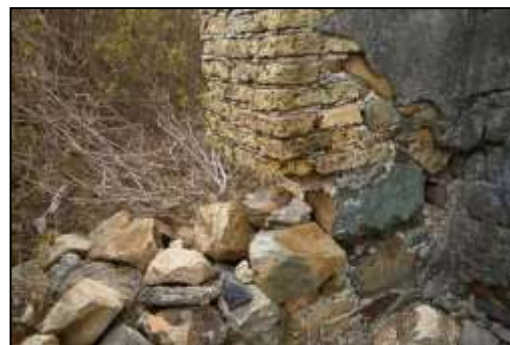
Only two small masonry piers survive on north and south ends of the west elevation. The northern pier is missing several courses of brick near the ground and is, for the most part, cantilevered out over the loose rocks of its foundation. This is a highly unstable situation and needs immediate stabilization. Other than the missing brick, the rest of the pier appears to be in good condition with only small areas of mortar loss being evident near the center of the surviving pier.

Figure 4 - Missing Masonry from North Pier

3. Rebuild the base of the Kitchen/Latrine's north pier on the western elevation using matching bricks and a naturally hydraulic mortar.
4. Replace the bricks and stones missing from the window jambs and heads. The most important window to rebuild is the southern window on the Kitchen/latrine's eastern elevation. Bed and point new material with naturally hydraulic lime.

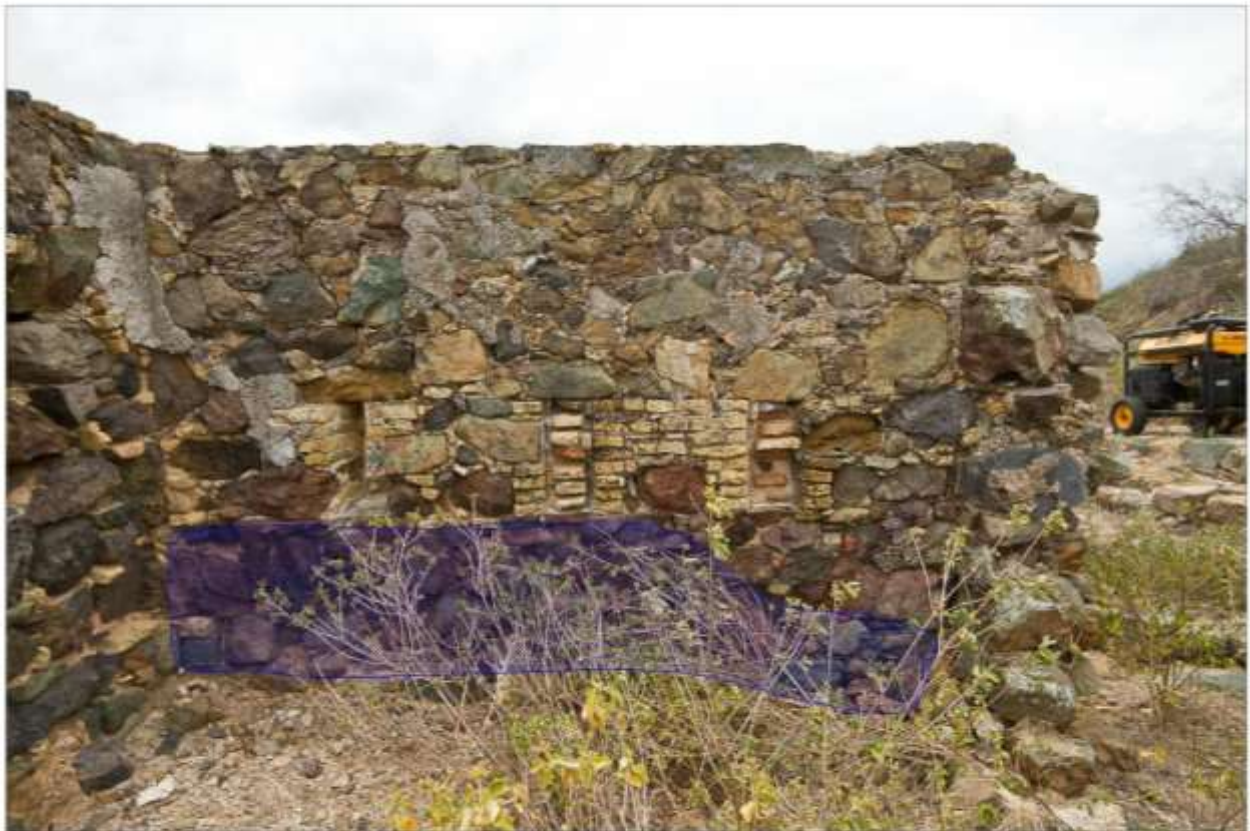
Kitchen/Latrine - Interior (South Elevation)

Similar to the southern exterior elevation the top third of the wall was either covered with cement stucco that has since fallen off or pointed with cement stucco. The lower two-thirds does not appear to have been stuccoed or repointed and shows a significant amount of mortar loss. No structural cracking is seen on this elevation.

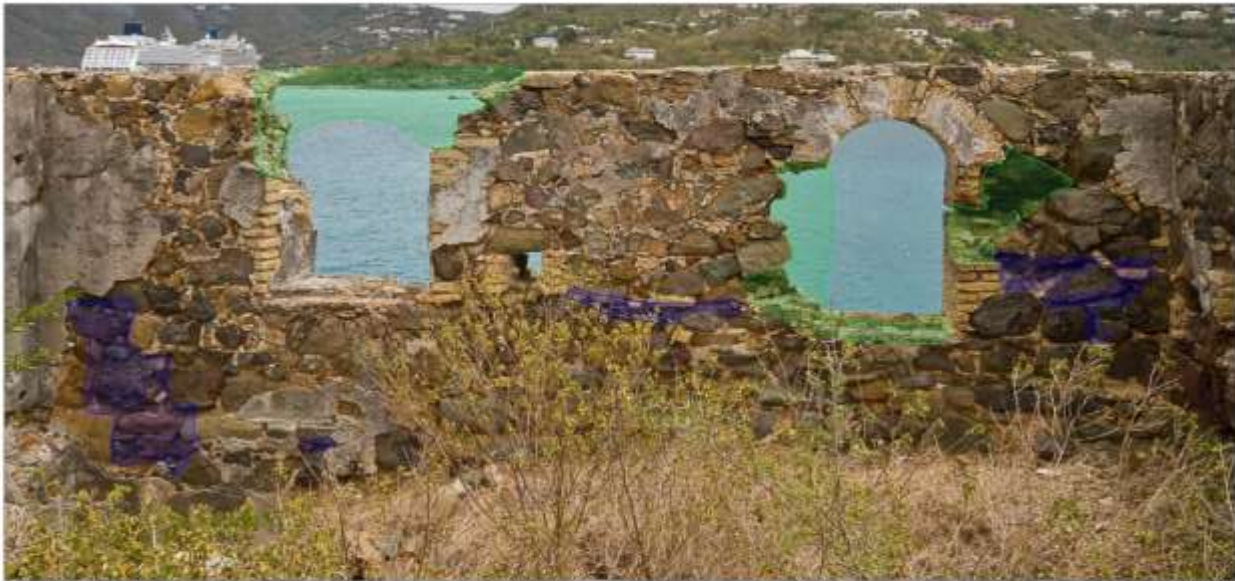
Kitchen/Latrine - Interior (East Elevation)

The east elevation includes two symmetrically placed windows and the arched head of the northern window has fallen in. Scattered remains of cement stucco are visible on approximately 10% of the elevation and, as with the south interior elevation, the upper portion of the wall is in better condition than the lower part. The principal conservation issue for this elevation is the missing bricks and stone from the southern window's jambs. The missing stones have structurally compromised the window opening and it is in immediate danger of collapsing (enough stonework has fallen away at this location that it is possible to look through the wall). Finally, mortar is missing from most of the lower wall.

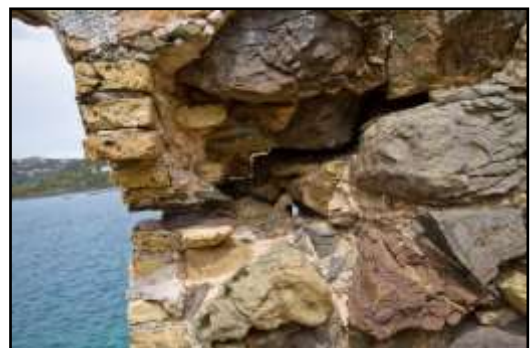
Figure 5 - Missing Masonry at Southern Window
