# Prince Frederick's Battery

KOCSA Analysis, Existing Conditions, and Stabilization Report

Arcadia Preservation, LLC  
Gardiner Hallock  
12/9/2011

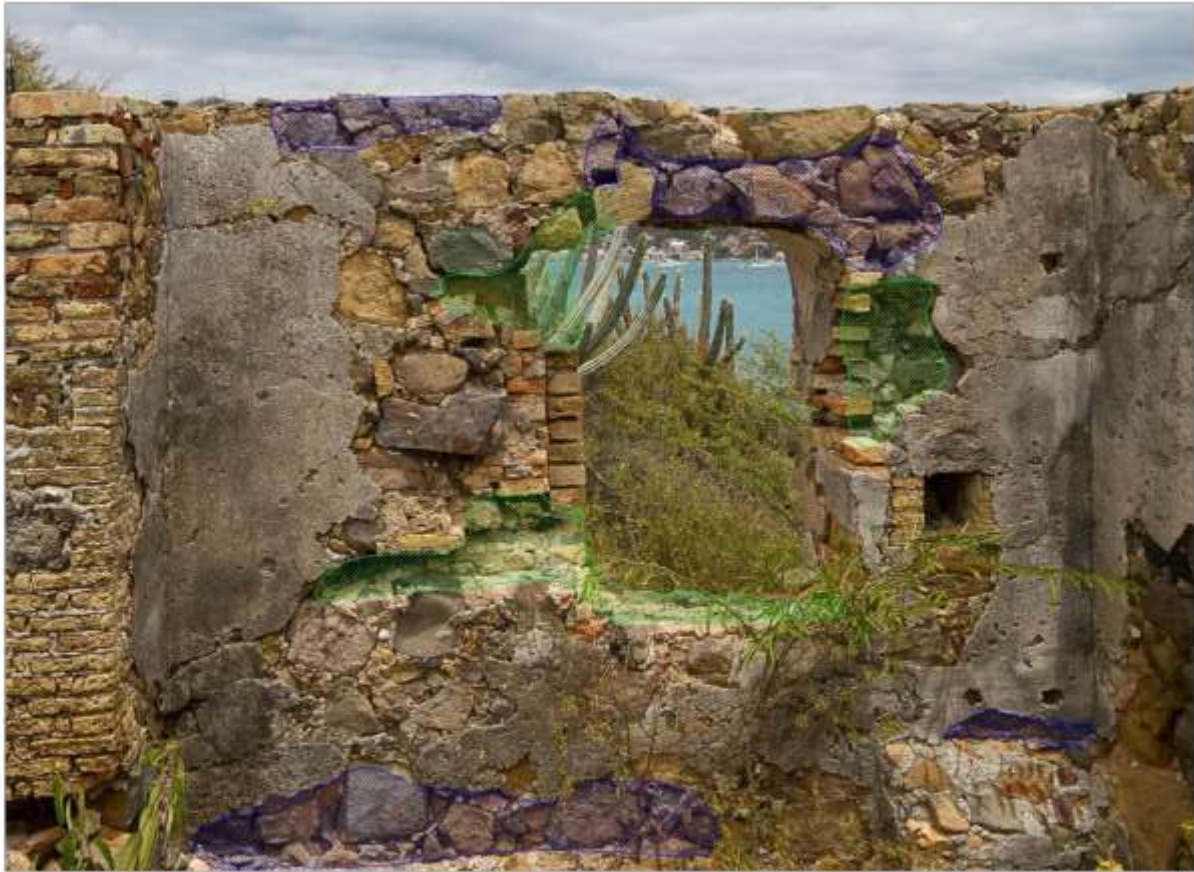
Kitchen/Latrine - Interior (North Elevation)

Both an almost centered window and a small, square aperture pierce the elevation which also features cement stucco over 66% of its surface. The main condition issue is a major loss of stone, brick, and mortar from around the window. Additionally, a large crack has developed that travels downward from the lower part of the window's western jamb to the western side of the wall.

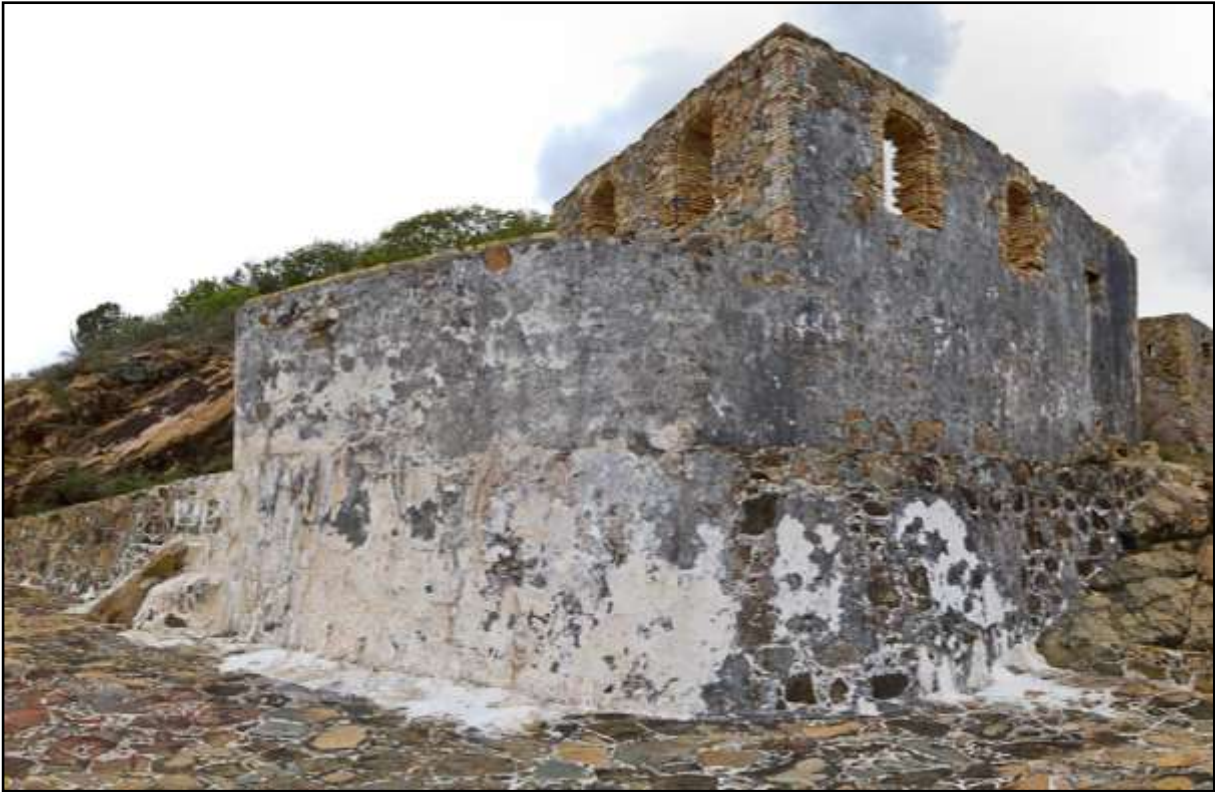
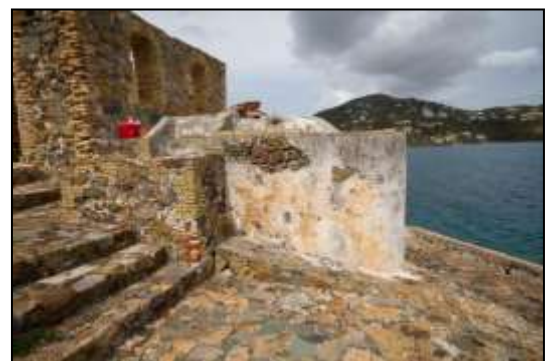
Figure 6 - Cistern, West Elevation

While the cistern is still holding water, which means much of the interior waterproofing is functioning, the heavy lime deposits on the wall below the cistern clearly show that water is slowly filtering through the masonry and dissolving the lime in the wall's mortar. The lime deposits appear to start at the bottom of the cistern and stream down to the surface of the terreplein along the entire length of the wall. The east wall is also covered with cement stucco. Small cracks in parging are found over much of the eastern elevation and a majority of the cracks found near the top where portions of the stucco have also fallen away. A majority of the cistern's small western elevation is also covered with cement stucco and it is in similar condition. The cistern's west elevation is also covered with stucco, a small portion of which has fallen away from the top of the north side. The stairs leading up to the cistern also need a limited amount of repointing. Finally, the top of the cistern is covered with a similar coating of cement stucco and it too is cracking and delaminating from approximately 50% of the masonry surface.

The cistern is clearly leaking and needs to be drained. The leaking is evidenced by the thick accumulation of calcified lime found below the cistern on the wall of the rampart. This deposit is not only an aesthetic issue but also a structural one as the calcium is at least partially coming from the lime in the mortar that holds the cistern walls and rampart together. The loss of lime from the mortar significantly weakens the structural integrity of the wall and will, eventually, lead to collapse. After the cistern is drained, the weep holes that drain water into the tank should be plugged and a cover should be installed over the main hatch. If the cistern is ever to be used again, a render of hydraulic lime with a coating of cement-based waterproofing should be applied over its interior.

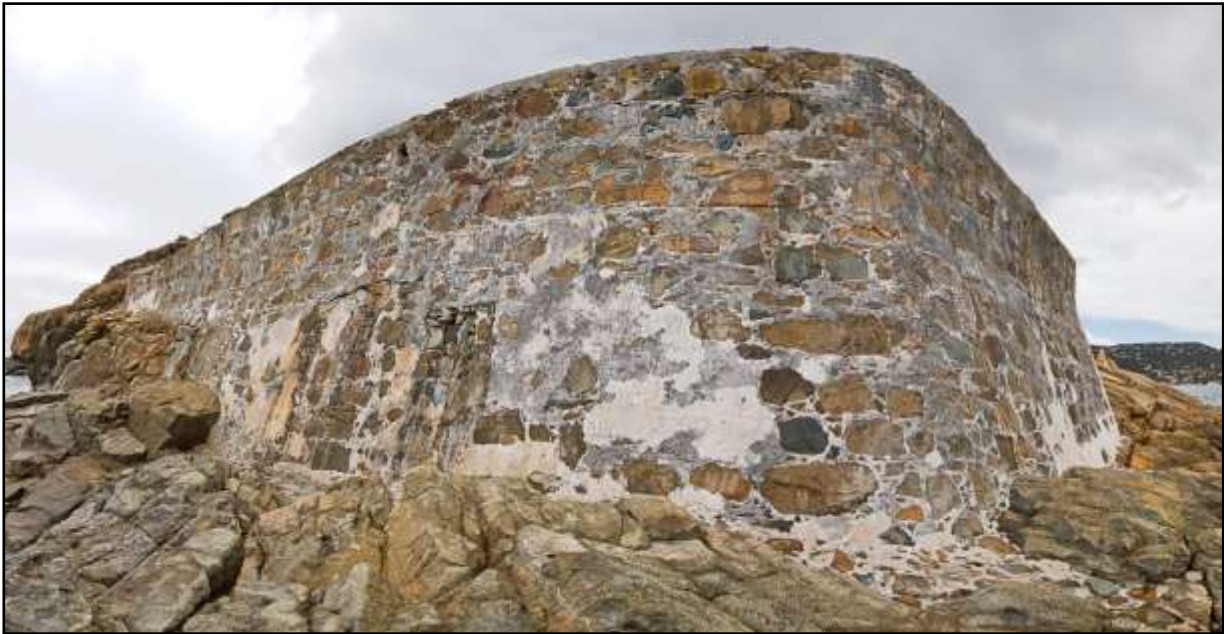
The rampart found below the terreplein is built from the same type of stones as the rest of the battery's structures but uses larger stones and features only a few scattered bricks fragments. The bottom two-thirds of the rampart is battered while the top third is plumb (or projecting slightly forward). A whitewashed cement stucco also once covered the rampart, but almost all of it has fallen off the wall. Principal conservation issues include horizontal cracks found close to where the battered section of the wall meets the plumb section. These cracks do not appear to be active and could be the result of earthquakes in the 19th century.<sup>ii</sup>

Other conservation issues include a damaged section of the wall that shows signs of water infiltration and cracks that are forming along the western edge of the rampart where it meets the bedrock. The source of the water infiltrating the rampart wall is not clear. It is unlikely to be coming from the cistern and the terreplein deck does not appear to be holding water. Regardless, the water infiltration is resulting in the loss of mortar from two fairly large areas on the rampart's southern elevation. While these areas can easily be repointed, without first fixing the problem, the mortar will fall away again. Possible solutions would involve repairing any areas of missing mortar on the terreplein, routinely inspecting the weep holes to make sure they are not blocked, and, just to be sure, draining the cistern.

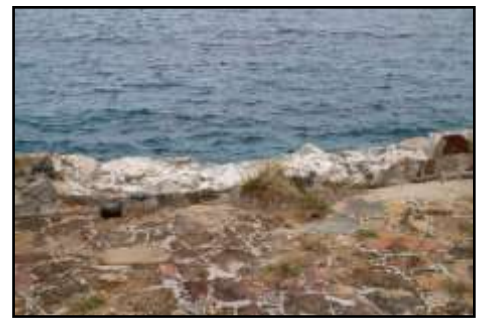
The stonework for the parapet is built of fieldstone masonry similar in appearance to the rest of the battery and shows similar condition issues, including loss of mortar and cement pointing. One exception is a large section of the parapet that is missing from the western end. Additionally, a small section in the center of the eastern parapet wall uses a concentration of red-colored stones, suggesting that it was rebuilt at some point in the past. Finally, almost the entire parapet wall has been at least partially repointed fairly recently with a grey-Portland cement based mortar. The repointing was poorly executed, is failing in some areas (due to too shallow joints), and was not properly struck.

Figure 7 - Detail of Missing Parapet Stonework

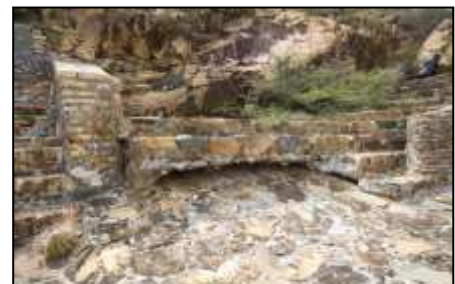
The walks and terreplein remain in good condition. In general, scattered areas of mortar loss are seen and grasses have started to grow out of some of the joints, but very few stones are missing and the surfaces appear to be stable. One exception is the foundation for the long stairs found on the western side of the foundation. A large portion of the stonework that supports the stairs is missing and the stairs are cantilevered over the terreplein.

Figure 8 - Terreplein Stairs with Missing Foundation

5. Rebuild the base of the stairs found on the west side of the terreplein using matching stones laid in a naturally hydraulic lime mortar.
6. Replace any stones or bricks that are missing in kind. Bed and point new material with naturally hydraulic lime.
