# Prince Frederick's Battery

KOCSA Analysis, Existing Conditions, and Stabilization Report

Arcadia Preservation, LLC  
Gardiner Hallock  
12/9/2011

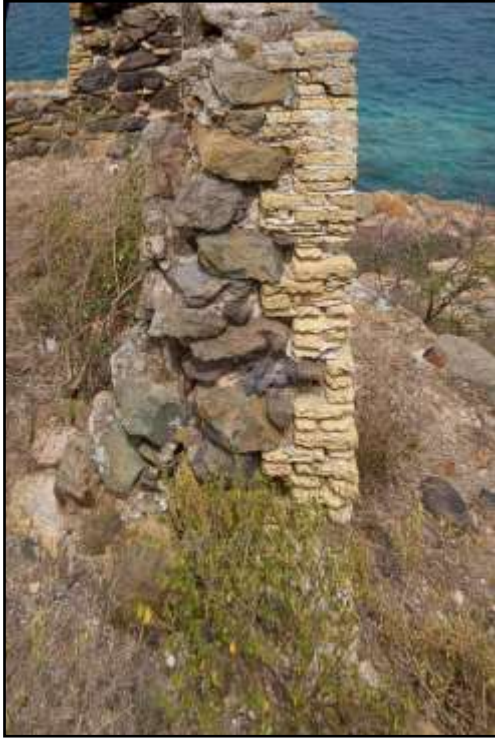
**Figure 1 - Brick and Stone Masonry Detail  
from the Kitchen/Latrine Building**

The structures, ramparts, parapets, and retaining walls found at Prince Frederik's battery are built from locally quarried field stone, yellow bricks, red brick rubble, and a small number of interspersed coral fragments. Historic records reveal that these materials were laid in a lime mortar. As is typical of other 18th-century buildings on St. Thomas, the windows, doors and corners of the two structures are formed from light yellow bricks keyed into the surrounding walls. The structures' stone foundations are also built directly onto the site's native rock or, in the case of the quarters, an extension of the rampart.

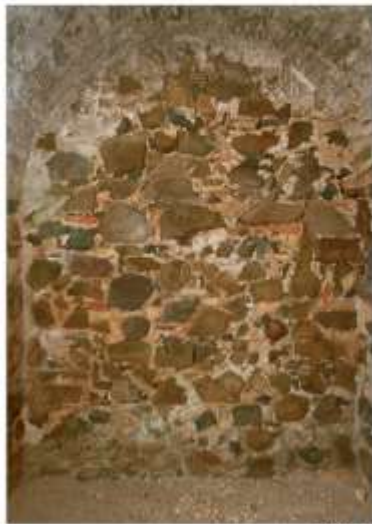
South Elevation

A single, asymmetrical arch-top door is found on the South elevation. The brickwork found around the door shows signs of major deterioration and is missing several bricks from the arch and jambs. Additionally, large areas of major mortar loss are seen around the doorway and minor areas of mortar loss are found across the elevation as a whole.

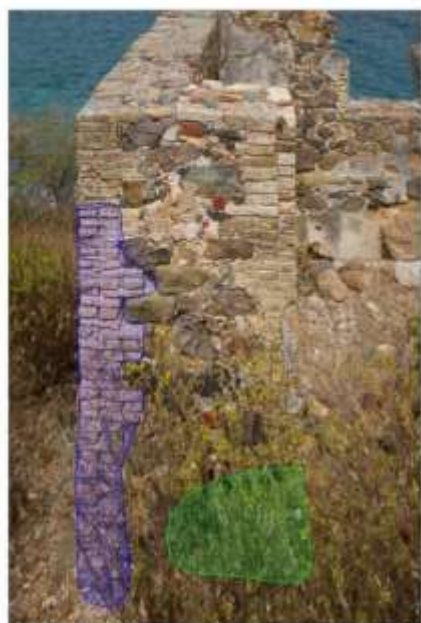
North Side

The north elevation features a single, symmetrically placed window and approximately 90 percent of the elevation is covered with cement stucco. The window appears to be a later addition, as it does not appear on the 1780 Oxholm drawing and is constructed slightly differently from the structure's other windows (it uses rougher laid brick work that does not completely surround the window). The principal conservation issue for the elevation is the loss of stone and mortar on the window's jambs. The loss of mortar also extends to portions of the stone and brickwork on either side of the window. Finally, a large crack is seen running upward from the lower corner of the window's western jamb towards the structure's northwestern corner. The crack appears to be structural and may relate to the window's failing masonry.
